الاتحاد العربي لمنتجي و ناقلي و موزعي الكهرباء
**Arab Union of Producers, Transporters,
and Distributors of Electricity**

لجنة تنسيق تشغيل شبكات الربط الكهربائي العربي
Committee of Interconnected Arab Networks
(CIAN)

Major Interruptions (blackouts) Study

March 2006

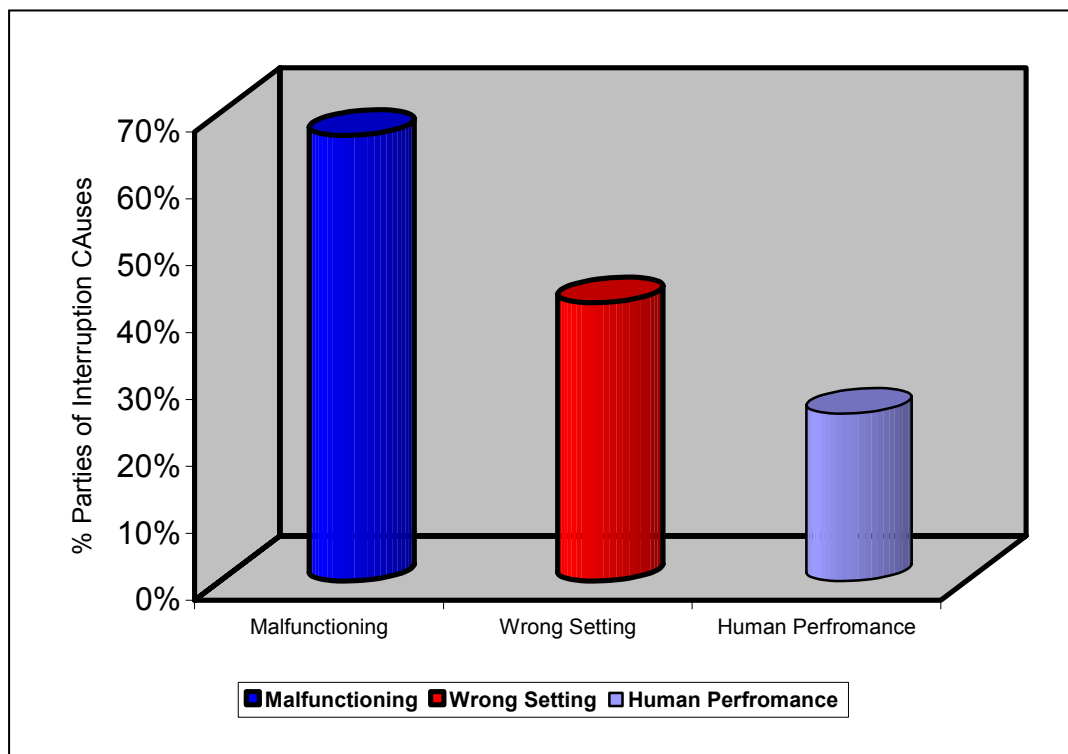
Figure 3.1: Contribution of Interruption Causes

From the given incidents, it is noticed that, interruptions due to equipment performance is common for the whole incidents (100% of the incidents are initiated partially or totally throughout equipment performance factors) while just 25 % of the whole incidents were partially initiated by the human error factors. In brief description, Table I and Fig (1) indicate for the interruption causes percentage parties where:

- Malfunctioning is presented in 66.6 % of incidents (8 out of 12 incidents)
- Wrong setting is presented in 41.6 % of incidents (5 out of 12 incidents)
- Human performance is presented in 25 % of incidents (3 out of 12 incidents).
